**Flood Control Project Maintenance
Levee Inspections**

Maintenance Issue Types Only, Levee Inspection Report By Mile - Spring 2017

Reclamation District No. 0349 Sutter Island

Waterway	Bank	Unit Miles	Inspection Start/End	Inspector
Unit No. 01 Sacramento River	Right	1.59	04/26/2017 04/26/2017	Herman Phillips

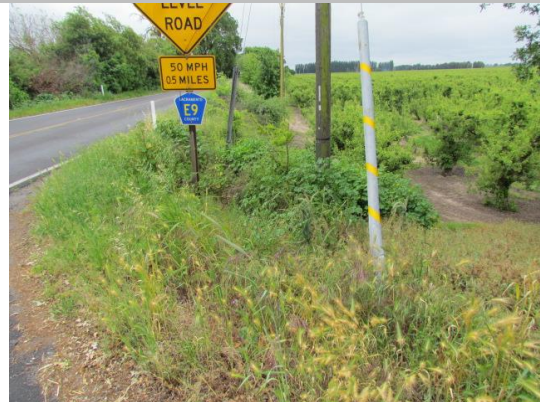
Photo 1 of 1 : SP_2017_RD0349_204_15_20170426_00024.jpg

LM Start	0.00	Rating **	U	Issue No.	15
LM End	0.99	Issue Type +	Ma	Location *	LS
Category	Earthen Levee			GPS Latitude/Longitude	
				Start	End
Item	Vegetation			38.327148 °	38.313078 °
				-121.576952 °	-121.578780 °
DWR ID	DWR_RD0349_01_f_2016_15				
Comment Code					
V1 : Control annual grass and weeds on the levee slopes and easements.					
Inspector Comment					
Control the wild growth of vegetation on the landside levee slope.

RD 349 Unit 1 levee mile 0.00 looking downstream landside slope.

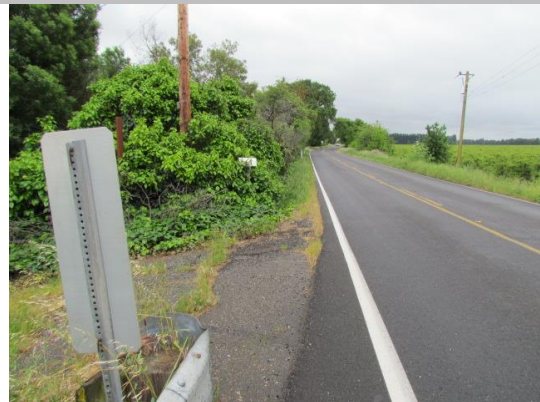
Photo 1 of 1 : SP_2017_RD0349_204_20_20170426_00025.jpg

LM Start	0.01	Rating **	U	Issue No.	20
LM End	0.94	Issue Type +	Ma	Location *	WS
Category	Earthen Levee			GPS Latitude/Longitude	
				Start	End
Item	Vegetation			38.327073 °	38.313798 °
				-121.576945 °	-121.578953 °
DWR ID	DWR_RD0349_01_s_2016_20				
Comment Code					
V2 : Remove the wild growth other than native grasses from the levee slopes.					
Inspector Comment					
Remove the unwanted wild growth of brush and other vegetation from the waterside slope. Unable to see the ground.

RD 349 Unit 1 Levee mile 0.01 waterside shoulder looking downstream.

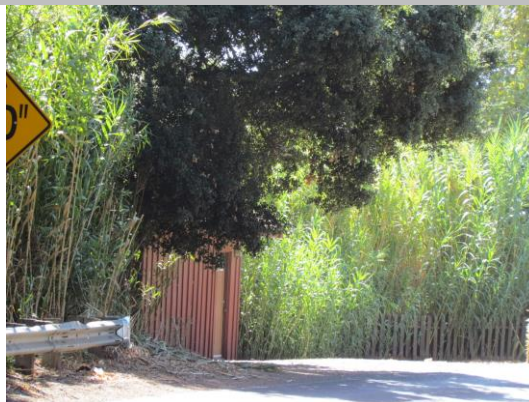
Photo 1 of 1 : SP_2017_RD0349_204_13_20170404_00002.jpg

LM Start	1.56	Rating **	U	Issue No.	13
LM End	1.58	Issue Type +	Ma	Location *	WS
Category	Earthen Levee			GPS Latitude/Longitude	
				Start	End
Item	Vegetation			38.305450 °	38.305162 °
				-121.574687 °	-121.574750 °
DWR ID	DWR_RD0349_01_f_2014_13				
Comment Code					
V2 : Remove the wild growth other than native grasses from the levee slopes.					
Inspector Comment					
This Arundo present on the waterward section is blocking the view of the levee section. Remove it from the shoulder and slope. This Arundo is so thick the entire slope is completely blocked from view.

RD 349 Unit 1 waterside shoulder and slope levee mile 1.56-1.58.

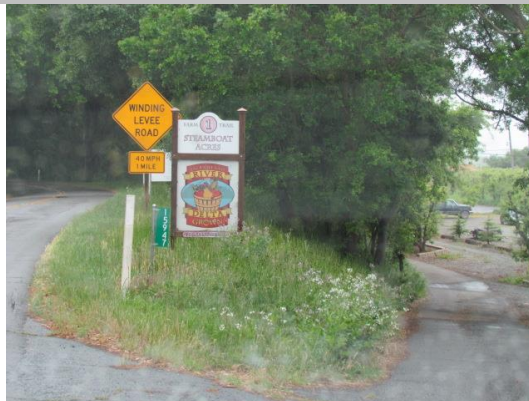
Photo 1 of 1 : SP_2017_RD0349_205_34_20170516_00082.jpg

LM Start	0.03	Rating **	U	Issue No.	34
LM End	1.31	Issue Type +	Ma	Location *	LS
Category	Earthen Levee			GPS Latitude/Longitude	
				Start	End
Item	Vegetation			38.304993 °	38.289043 °
				-121.575160 °	-121.584015 °
DWR ID	DWR_RD0349_02_f_2016_34				
Comment Code					
V1 : Control annual grass and weeds on the levee slopes and easements.					
Inspector Comment					
Control the annual grasses and weeds from the slope and berm.

RD 349 Unit 2 landside.

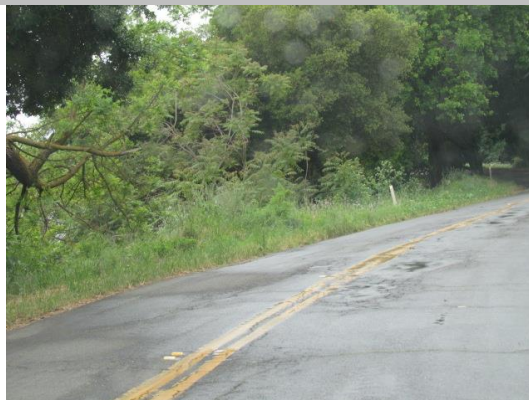
Photo 1 of 1 : SP_2017_RD0349_205_37_20170516_00083.jpg

LM Start	0.04	Rating **	U	Issue No.	37
LM End	0.52	Issue Type +	Ma	Location *	WS
Category	Earthen Levee			GPS Latitude/Longitude	
				Start	End
Item	Vegetation			38.304928 °	38.300007 °
				-121.575310 °	-121.581023 °
DWR ID	DWR_RD0349_02_s_2017_37				
Comment Code					
V1 : Control annual grass and weeds on the levee slopes and easements.					
Inspector Comment					
Spray and mow the waterside slope and shoulder.

RD 349 Unit 2 looking at the waterside slope and shoulder.

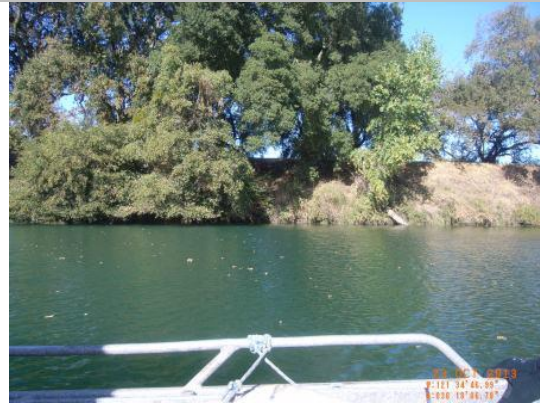
Photo 1 of 1 : SP_2017_RD0349_205_9_20170404_00008.jpg

LM Start	0.34	Rating **	M	Issue No.	9
LM End	0.39	Issue Type +	Ma	Location *	WS
Category	Supplemental			GPS Latitude/Longitude	
				Start	End
Item	2015 USACE Erosion Survey, DRAFT			38.302358 °	38.301772 °
				-121.579707 °	-121.580093 °
DWR ID	DWR_RD0349_02_s_2016_9				
Comment Code					
Inspector Comment					
2007 - Slow erosion, probably due to wave wash and fluvial erosion. Site has likely been here for awhile but was unseen due to boats parked in front. 2015: Large tree popout, scarp reaches crown of levee. [2015 Site ID: STM_25-8_R]

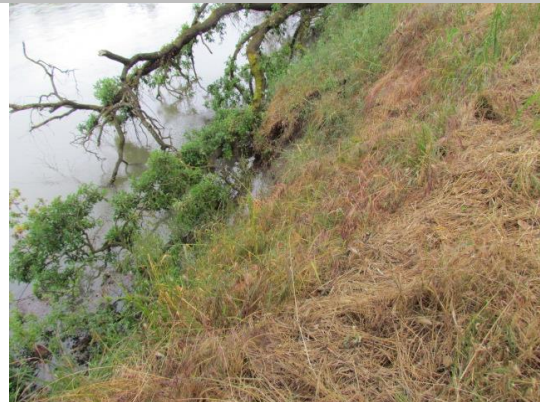
Photo 1 of 1 : SP_2017_RD0349_205_39_20170516_00086.jpg

LM Start	0.35	Rating **	U	Issue No.	39
LM End	0.35	Issue Type +	Ma	Location *	WS
Category	Earthen Levee			GPS Latitude/Longitude	
				Start	End
Item	Slope Stability			38.302368 °	38.302368 °
				-121.579933 °	-121.579933 °
DWR ID	DWR_RD0349_02_s_2017_39				
Comment Code					
S1 : Repair slope instability.					
Inspector Comment					
This erosion occurred during the Feb Storm 2017 event. This site need immediate attention,

RD 349 Unit 2 levee mile 0.35 waterside slope and shoulder.

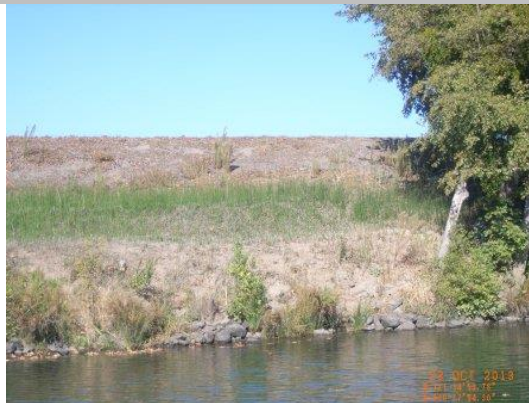
Photo 1 of 1 : SP_2017_RD0349_205_13_20170404_00011.jpg

LM Start	0.60	Rating **	M	Issue No.	13
LM End	0.72	Issue Type +	Ma	Location *	WS
Category	Supplemental			GPS Latitude/Longitude	
				Start	End
Item	2015 USACE Erosion Survey, DRAFT			38.298897 °	38.297384 °
				-121.581571 °	-121.582176 °
DWR ID	DWR_RD0349_02_s_2016_13				
Comment Code					
Inspector Comment					
2010 - Small maintenance, erosion into the toe. 2011 - Minor new erosion at toe. 2015: Minor new erosion at toe, new tree popout. [2015 Site ID: STM_25-5_R]

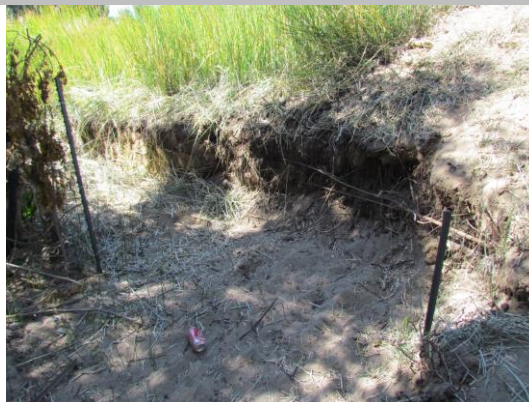
Photo 1 of 2 : SP_2017_RD0349_205_36_20170404_00016.jpg

LM Start	1.08	Rating **	U	Issue No.	36
LM End	1.08	Issue Type +	Ma	Location *	WS
Category	Earthen Levee			GPS Latitude/Longitude	
				Start	End
Item	Erosion / Bank Caving			38.292380 °	38.292282 °
				-121.583963 °	-121.583958 °
DWR ID	DWR_RD0349_02_f_2016_36				
Comment Code					
E2 : Schedule repair of erosion site prior to the next inspection.					
Inspector Comment					
Land owner damaged the slope waterside. The damage need to be repaired soon as possible.

RD 349 Unit 2 waterside slope and berm Land owner has dug a pit.

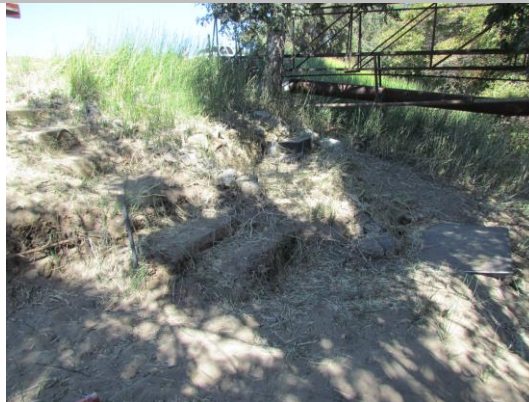
Photo 2 of 2 : SP_2017_RD0349_205_36_20170404_00018.jpg

The landowner has knotted step into the waterside slope.

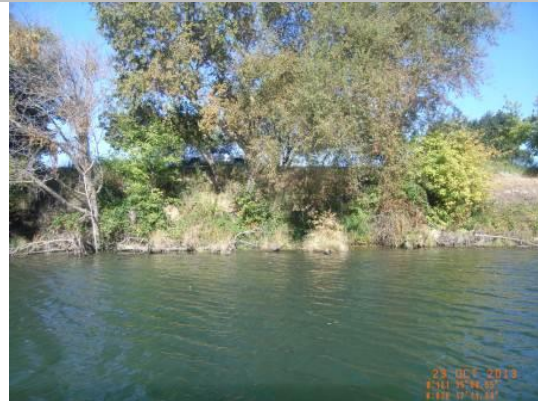
Photo 1 of 1 : SP_2017_RD0349_205_10_20170404_00009.jpg

Comment Code					
Inspector Comment					
1997 - Erosion of very sandy levee behind large stand of riparian vegetation on top right bank. Dry ravel of sand. 1999 - Quarry waste rock was dumped down the levee slope; poor repair job; still eroding in places. Eroding at midslope off fabric. 2005 - Length revised, only the middle 150 - 200 ft are eroding. 2006 - Some rock/small material dumped down the bank but it is slowly unraveling. Upstream end is unraveling faster. Steep slope with poor gradation so fines are washing out. 2010 - Lots of overhanging trees and erosion pockets. 2011 - This site is upgraded to CRITICAL. Near vertical bank at the downstream end. New erosion at various locations throughout the site. 2015: No observed changes. [2015 Site ID: STM_24-7_R]

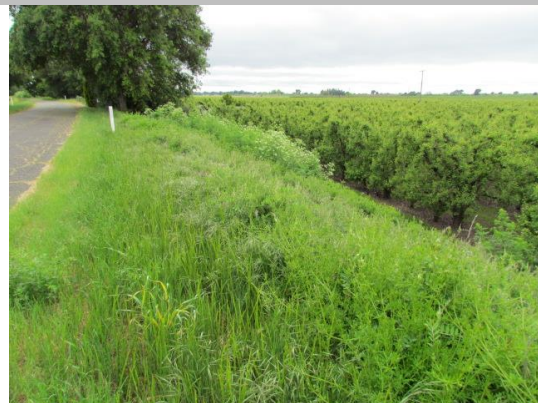
Photo 1 of 1 : SP_2017_RD0349_205_47_20170516_00088.jpg

LM Start	1.77	Rating **	U	Issue No.	47
LM End	4.30	Issue Type +	Ma	Location *	LS
Category	Earthen Levee			GPS Latitude/Longitude	
				Start	End
Item	Vegetation			38.284002 °	38.254703 °
				-121.588933 °	-121.599700 °
DWR ID	DWR_RD0349_02_s_2017_47				
Comment Code					
V2 : Remove the wild growth other than native grasses from the levee slopes.					
Inspector Comment					
Remove the wild growth other than native grasses from the landside levee slope.

RD 349 Unit 2 levee mile 1.77-3.79 landside slope and shoulder.

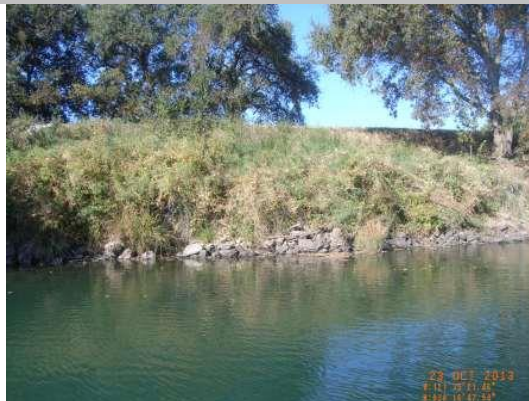
Photo 1 of 1 : SP_2017_RD0349_205_19_20170404_00013.jpg

LM Start	2.04	Rating **	M	Issue No.	19
LM End	2.05	Issue Type +	Ma	Location *	WS
Category	Supplemental			GPS Latitude/Longitude	
				Start	End
Item	2015 USACE Erosion Survey, DRAFT			38.280069 °	38.279919 °
				-121.589443 °	-121.589438 °
DWR ID	DWR_RD0349_02_s_2016_19				
Comment Code					
Inspector Comment					
2011 - Small scallop caused by erosion and wave wash. 2015: No observed changes. [2015 Site ID: STM_24-1_R]

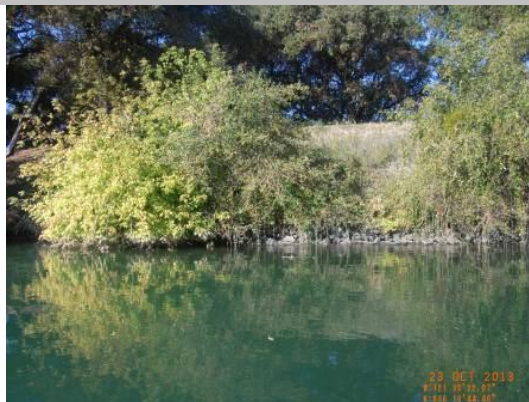
Photo 1 of 1 : SP_2017_RD0349_205_16_20170404_00012.jpg

LM Start	2.11	Rating **	M	Issue No.	16
LM End	2.14	Issue Type +	Ma	Location *	WS
Category	Supplemental			GPS Latitude/Longitude	
				Start	End
Item	2015 USACE Erosion Survey, DRAFT			38.279017 °	38.278597 °
				-121.589615 °	-121.589854 °
DWR ID	DWR_RD0349_02_s_2016_16				
Comment Code					
Inspector Comment					
1997 - Top right bank has retreated into the levee. Site is between two rock sites. 1999 - Downstream half of the reach repaired with rock. 2000 - Trees leaning into the water. 2010 - Site appears worse. 2011 - New erosion at the toe. 2013 - Short vertical sections observed at upstream end. 2015: Minor new erosion. [2015 Site ID: STM_23-9_R]

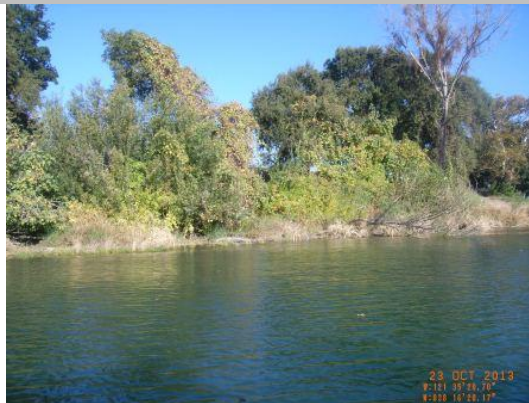
Photo 1 of 2 : SP_2017_RD0349_205_3_20170404_00004.jpg

LM Start	2.56	Rating **	M	Issue No.	3
LM End	2.69	Issue Type +	Ma	Location *	WS
Category	Supplemental			GPS Latitude/Longitude	
				Start	End
Item	2015 USACE Erosion Survey, DRAFT			38.273854 °	38.271998 °
				-121.588745 °	-121.589424 °
DWR ID	DWR_RD0349_02_s_2016_3				
Comment Code					
Inspector Comment					
2011 - Toe scour at the tidal zone. 2015: New tree popout and minor new erosion. [2015 Site ID: STM_23-6_R]

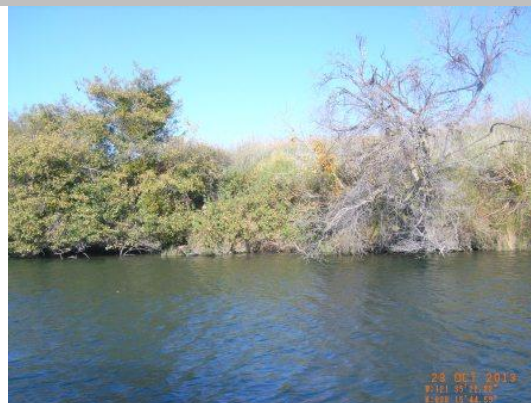
Photo 1 of 1 : SP_2017_RD0349_205_11_20170404_00010.jpg

LM Start	3.38	Rating **	M	Issue No.	11
LM End	3.49	Issue Type +	Ma	Location *	WS
Category	Supplemental			GPS Latitude/Longitude	
				Start	End
Item	2015 USACE Erosion Survey, DRAFT			38.262510 °	38.262533 °
				-121.589481 °	-121.591690 °
DWR ID	DWR_RD0349_02_s_2016_11				
Comment Code					
Inspector Comment					
2010 - Slumping sections on the lower bank, appears to be scouring around the trees. 2011 - Soil beach at toe. 2015: No observed changes. [2015 Site ID: STM_22-8_R]

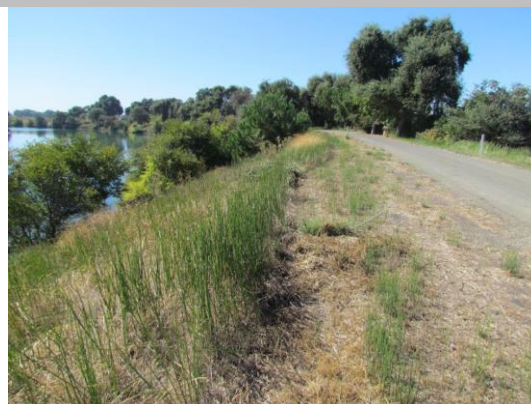
Photo 1 of 1 : SP_2017_RD0349_205_84_20170404_00027.jpg

LM Start	3.58	Rating **	U	Issue No.	84
LM End	4.31	Issue Type +	Ma	Location *	WS
Category	Earthen Levee			GPS Latitude/Longitude	
				Start	End
Item	Vegetation			38.262588 °	38.254733 °
				-121.593328 °	-121.599963 °
DWR ID	DWR_RD0349_02_f_2015_84				
Comment Code					
V2 : Remove the wild growth other than native grasses from the levee slopes.					
Inspector Comment					
Remove the snap grasses from the waterside levee slope.

Tall snap grasses covering the waterward slope. No change.

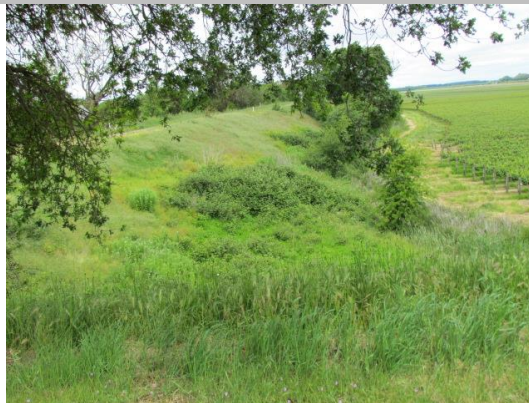
Photo 1 of 1 : SP_2017_RD0349_206_34_20170522_00078.jpg

RD 349 Unit 4 levee mile 0.00 landside slope and shoulder.

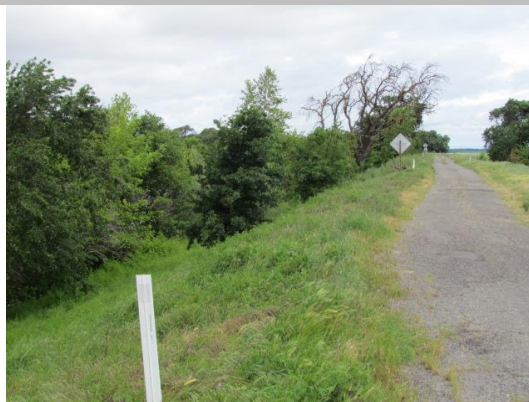
Photo 1 of 1 : SP_2017_RD0349_206_35_20170522_00079.jpg

LM Start	0.00	Rating **	U	Issue No.	35	
LM End	2.74	Issue Type +	Ma	Location *	WS	
Category	Earthen Levee			GPS Latitude/Longitude		
				Start		End
Item	Vegetation			38.254752 °		38.292205 °
				-121.600067 °		-121.603727 °
DWR ID	DWR_RD0349_03_f_2016_35					
Comment Code						
V1 : Control annual grass and weeds on the levee slopes and easements.						
Inspector Comment						
Tall weeds on the waterside levee slope need to be removed.

RD 349 Unit 4 levee mile 0.00 waterside slope.

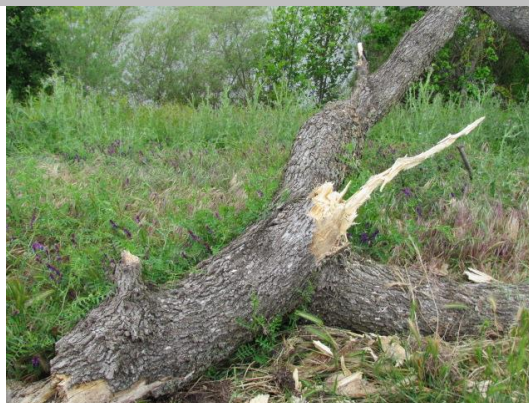
Photo 1 of 1 : SP_2017_RD0349_206_37_20170522_00077.jpg

RD 349 Unit 4 levee mile 0.04 Dead tree on the waterside shoulder and crown roadway.

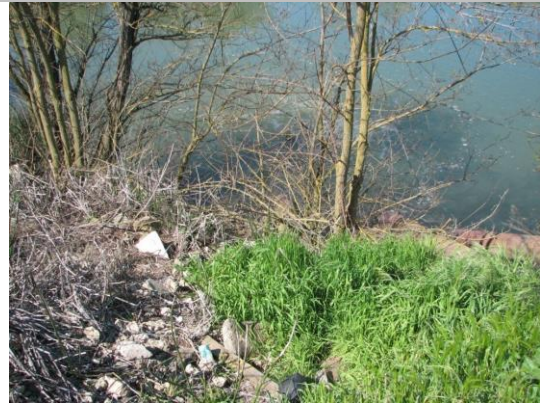
Photo 2 of 2 : UCIP_SP_2017_43446_36726.jpg

Comment Code						
Inspector Comment						
FS_ID:43446 DS_ID:24229 EP_NO: 2954 Repair Type: Non-Urgent Crossing Status: Found UCIP Comments: Dense vegetation limits the inspector's visibility to identify signs of pipe failure (leaks) through the levee slopes. Recommend removing vegetation along pipe alignment to conduct proper inspection of structure and appurtenances. Note date on photos should be 3/18/09 not 7/26/08 camera metadata is incorrect. FIELD_STRUCT_DESC: [R.D. No. 349 Drainage Pumping Plant] 1 of 3: 18-inch pipe through the levee, 7.8 feet below the crown. Siphon breakers on waterward slope. Pumps on platform on landward side. FS Date: 3/19/2009

View of all 3 pipes through levee and visible on waterward toe.

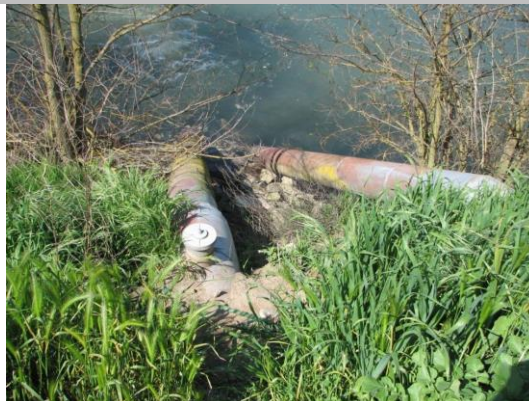
Photo 2 of 3 : UCIP_SP_2017_43445_36727.jpg

FS_ID:43445
DS_ID:24228
EP_NO: 2954
Repair Type: Non-Urgent
Crossing Status: Found
UCIP Comments: Dense vegetation limits the inspector's visibility to identify signs of pipe failure (leaks) along the slope. Recommend removing vegetation along pipe alignment to conduct proper inspection of structure and appurtenances. Note date on photos should be 3/18/09 not 7/26/08 camera metadata is incorrect.
FIELD_STRUCT_DESC: [R.D. No. 349 Drainage Pumping Plant] 2 of 3: 24-inch pipe through the levee, 7.8 feet below the crown. Siphon breakers on waterward slope. Pumps on platform on landward side.
FS Date: 3/19/2009

View of pipe on waterward side--pipe running. Siphon breaker visible on pipe.

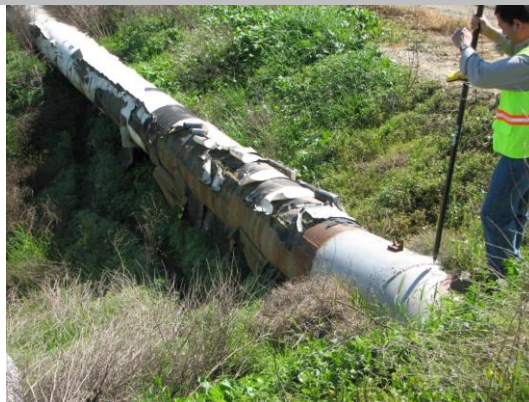
Photo 3 of 3 : UCIP_SP_2017_43445_36728.jpg

Pipe is wrapped--unwrapped coating.

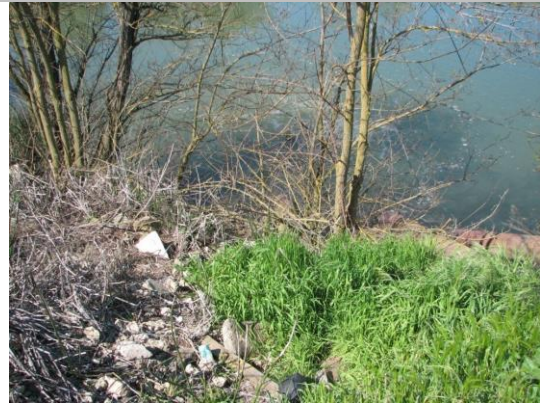
Photo 3 of 3 : UCIP_SP_2017_21632_36734.jpg

Comment Code					
Inspector Comment					
FS_ID:21632 DS_ID:24171 EP_NO: 2954 Repair Type: Non-Urgent Crossing Status: Found UCIP Comments: Dense vegetation limits the inspector's visibility to identify signs of pipe failure (leaks) along the slope. Recommend removing vegetation along pipe alignment to conduct proper inspection of structure and appurtenances. Note date on photos should be 3/18/09 not 7/26/08 camera metadata is incorrect. FIELD_STRUCT_DESC: [R.D. No. 349 Drainage Pumping Plant] 3 of 3: 24-inch pipe through the levee, 7.8 feet below the crown. Metal cutoff wall around pipe at landward shoulder. Siphon breakers on waterward slope. Two anchor posts driven into levee on each side of pipe. Pumps on platform on landward side. (Permit No. 2954-1959) FS Date: 3/19/2009

All 3 pipes visible on waterward side--tall grass limits inspection on waterward side.

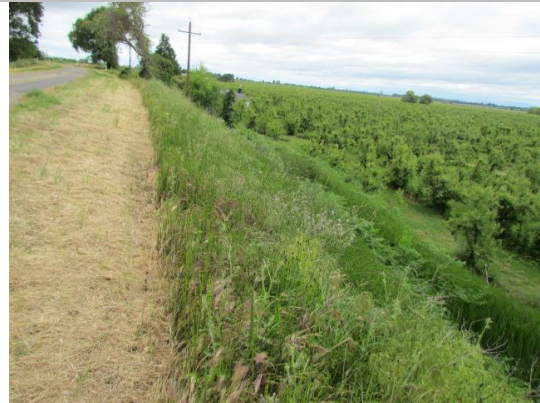
Photo 1 of 1 : SP_2017_RD0349_206_47_20170522_00076.jpg

RD 349 Unit 4 looking from levee mile 1.89 landside slope and berm.

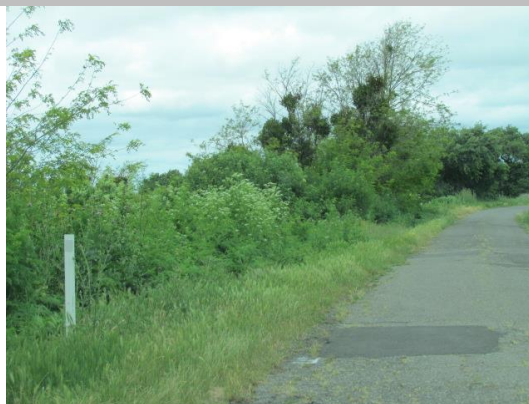
Photo 1 of 1 : SP_2017_RD0349_206_73_20170522_00080.jpg

RD 349 Unit 4 waterside shoulder and slope.levee mile 3.01-6.33.

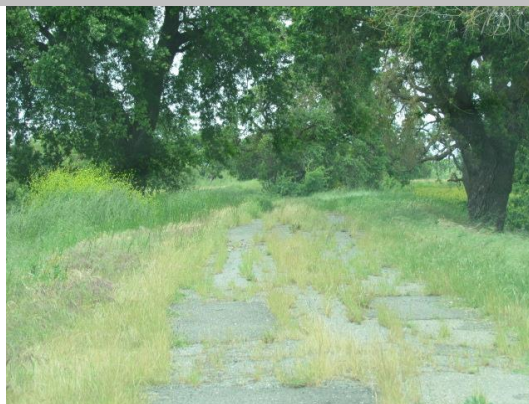
Photo 1 of 1 : SP_2017_RD0349_206_50_20170522_00081.jpg

LM Start	3.99	Rating **	U	Issue No.	50
LM End	6.33	Issue Type +	Ma	Location *	CR
Category	Earthen Levee			GPS Latitude/Longitude	
				Start	End
Item	Vegetation			38.307972 °	38.328778 °
				-121.597037 °	-121.579013 °
DWR ID	DWR_RD0349_03_s_2017_50				
Comment Code					
V9 : Keep the crown roadway free of vegetation.					
Inspector Comment					
Keep the crown roadway free of vegetation.

RD 349 Unit 4 levee mile 3.99 -6.33 crown roadway.
